# JEWELRY DISTRIBUTOR CASE STUDY

*For Testing, Adjusting, & Balancing by Melink Corporation*

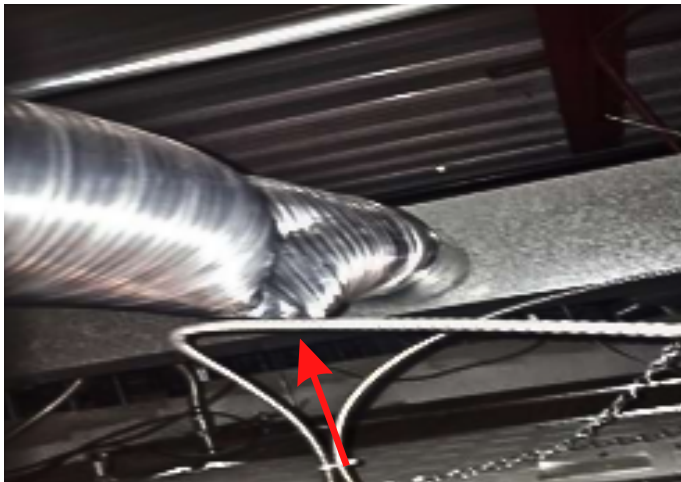
*A section of rooftop unit ductwork that is dented and is not properly serving airflow to the connected diffuser.*

performance and comfort levels in the warehouse. Key actions included reconnecting VFDs to restore efficiency, minor ductwork repairs to enhance airflow, and temporary solutions to damaged OA dampers to improve ventilation. In addition to these immediate improvements, the technician also provided the jewelry distributor with a detailed list of further actions required to fully address the airflow and comfort issues. This included replacing pulleys, installing remote sensors, and conducting extensive ductwork repairs.

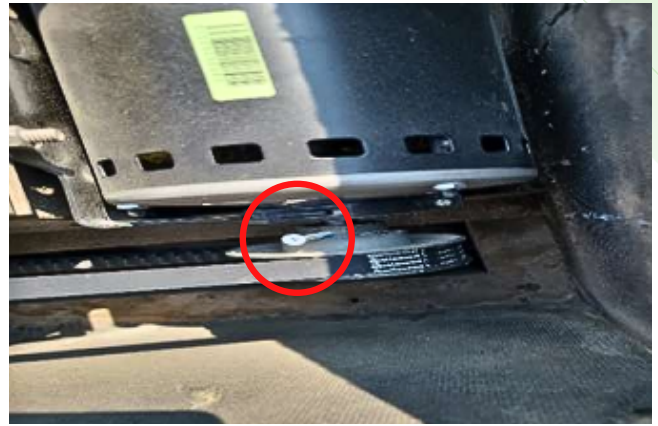
*An exhaust fan motor pulley that is secured with a screw.*
