National Coffee Retailer

CASE STUDY

Quality Inspection Verification

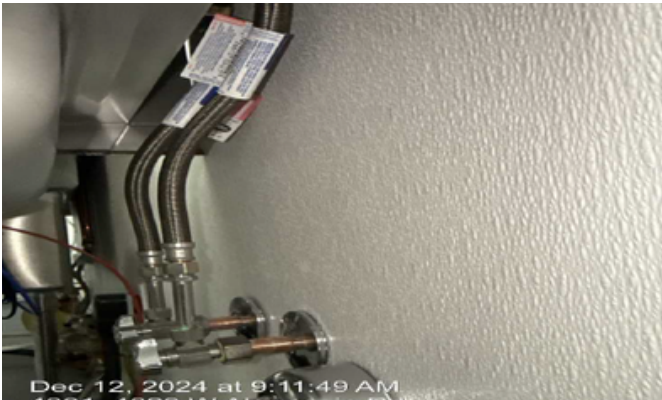
Missing TMV in the workroom.

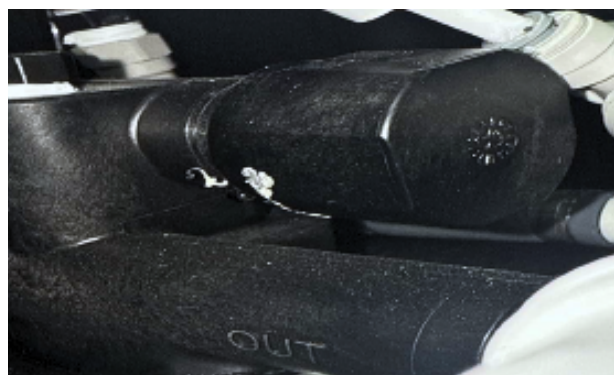
RO system is leaking.

5	Plumb (3)	A small water leak was found in the RO system above the cartridges.

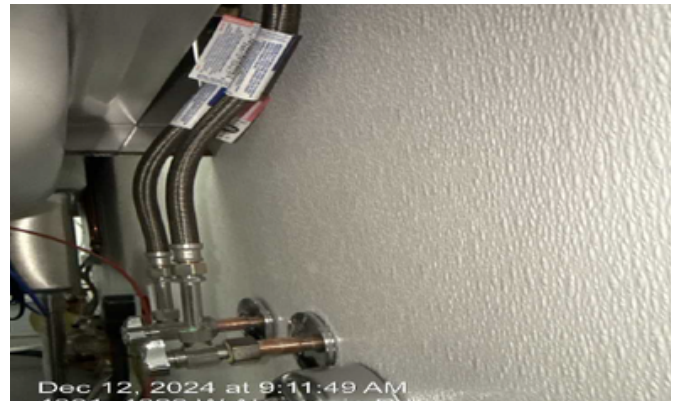
Missing TMV in the workroom.
